### Division of Oil, Gas and Mining

## Minerals Inspection Report

Mine Name: Asphalt Ridge 2	Permit Number: M/47/0032	Mine Status: Inactive
Operator Name: Tar Sands Holdings II	Inspection Date: 3/15/2016	Permit Fees: Paid
Inspector(s): A. Abate	Inspection Time: 2:00 PM	Bond Amount: \$376,000
Attendee(s): A. Burrows, R. Tanner, Operators	Weather: Clear 65 F	Bond Escalation: 3/15/2014
Inspection Purpose: Follow up from enforcement		Prior Inspection: 6/1/2015

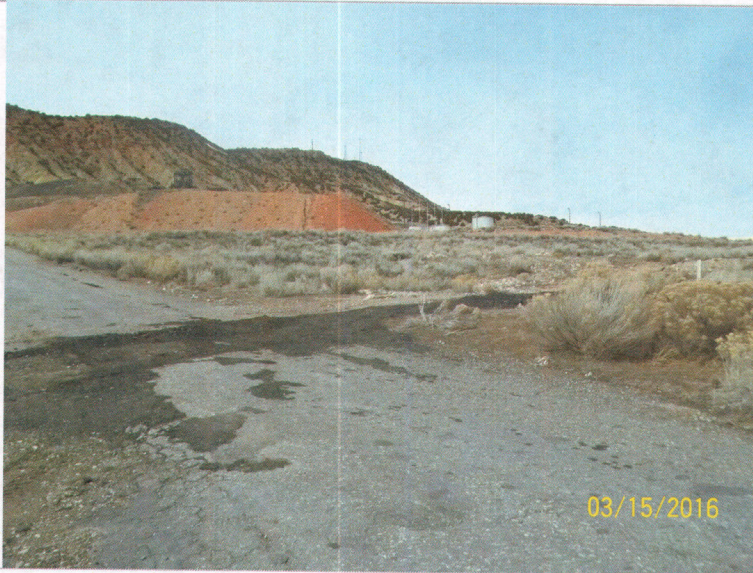
Construction of diversion berms along the mine roads.

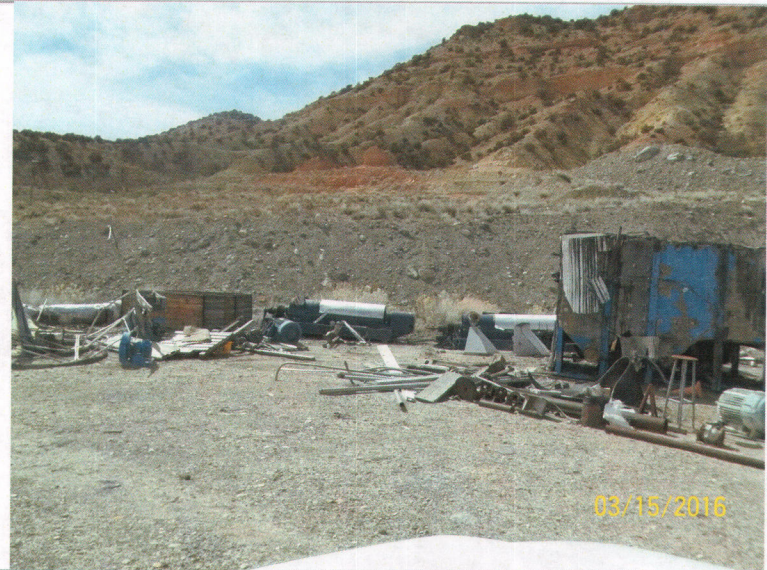
Scrap metal from the boneyard area.

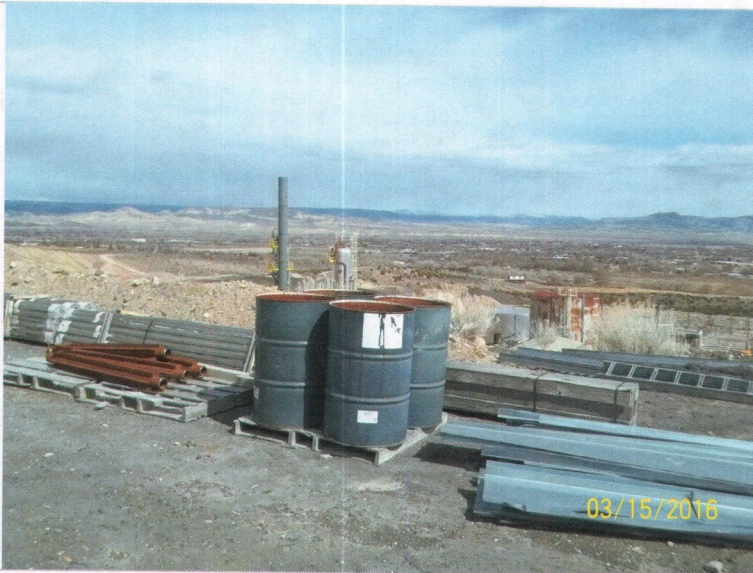
4.	Deleterious Material	<input checked="" type="checkbox"/>	<input checked="" type="checkbox"/>
<p>The boneyard area contained several large piles of scrap metal. A group of approximately (4) 55-gallon drums were observed unlabeled and without lids. A crusty, sludge material was observed inside these drums. A second area which appeared to be a hazmat staging location was also observed to contain several 55-gallon drums, open bins containing oil and multiple 5-gallon buckets. Most of which were also without lids and contained a crusty sludge material. The condition of these drums, along with an unknown material exposed to the environment presents an imminent hazard and requires immediate characterization and proper removal from the site by a licensed contractor.</p>

Four, unlabeled, unlidded 55-gallon drums

Notice of Violation (NOV) MN-2016-60-02 was issued on March 23, 2016 for the imminent hazard of deleterious materials discovered in on-site containers. The containers are required to be characterized and properly removed by a licensed contractor within 21 days of NOV issuance. Scrap metal should also be removed from the boneyard area. Additional drainage diversions should be constructed where areas of standing water are present near the mine pit.

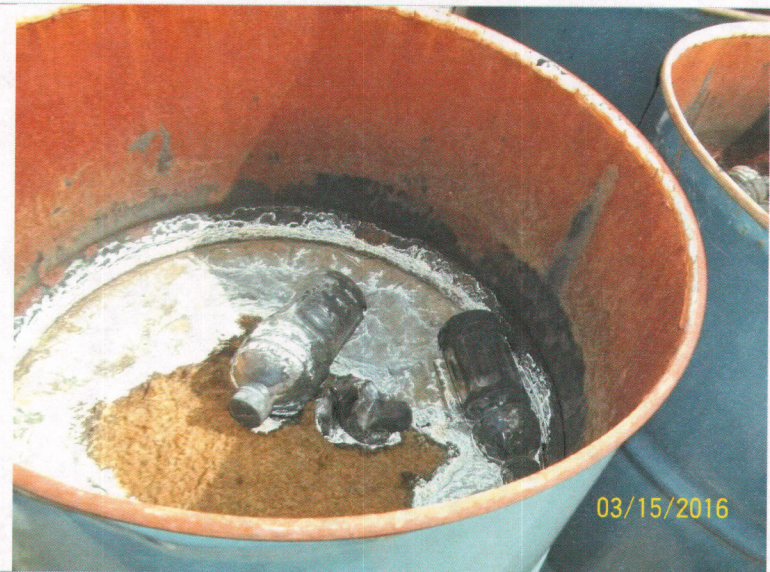
The contents inside the drums.

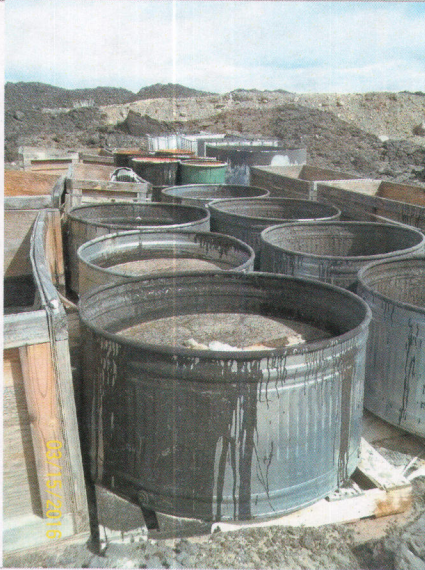
Open bins, 55-gallon drums, and 5-gallon buckets improperly stored in a hazmat storage area.

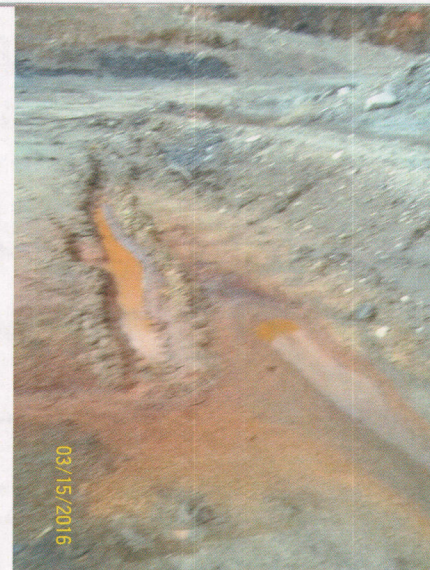
Standing water running along the roads near the mine pits were noted.
